The Forest Ridge Association

Dayton, OH • July 29, 2022

FULL RESERVE STUDY

Visual Inspection and Report by: Matthew C. Ferguson, RS¹

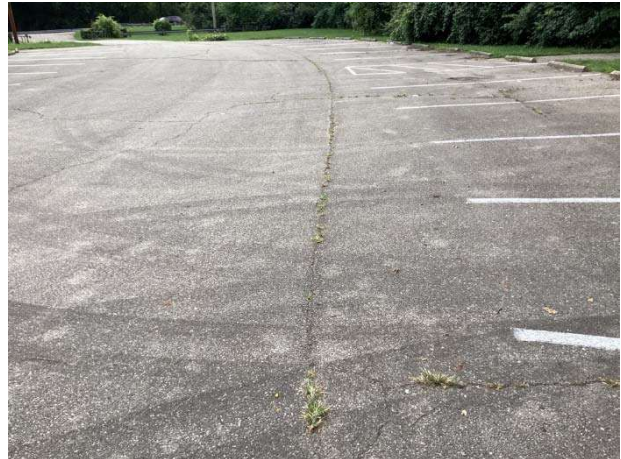
Pavement cracks at pool house

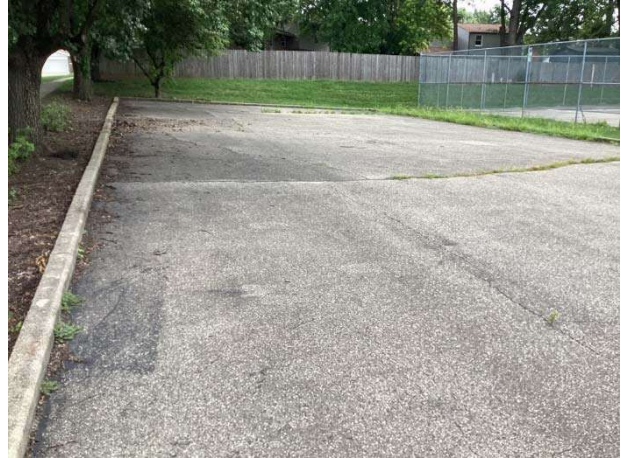
Willow Branch Drive asphalt pavement parking lot overview

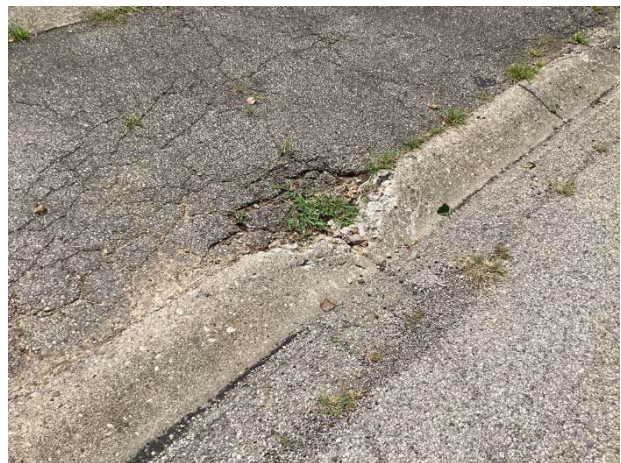
Condition: Fair overall with isolated damage and cracks evident.

Concrete damage (Willow Branch Drive shown)

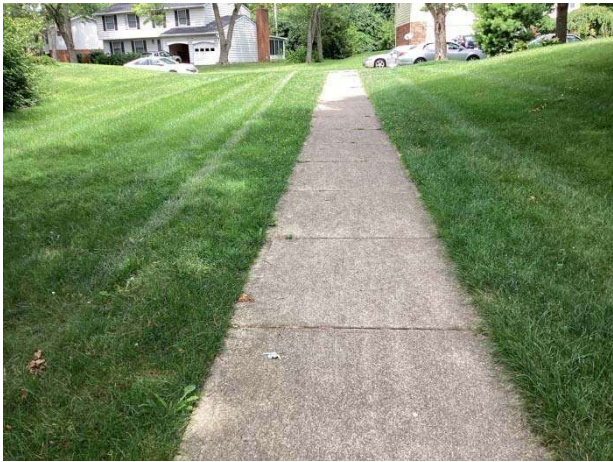
Sidewalk cracks

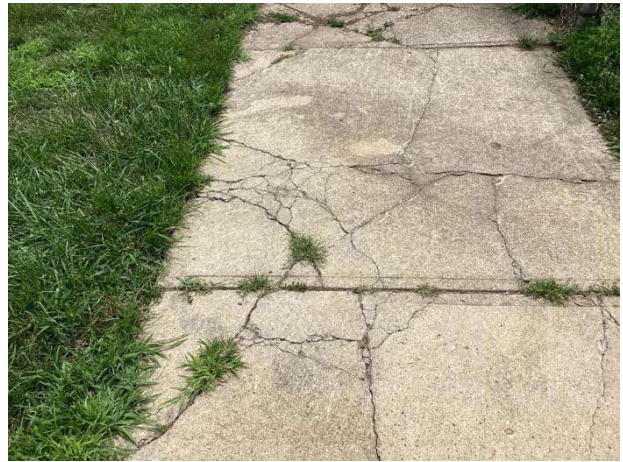
Sidewalk cracks near pool house

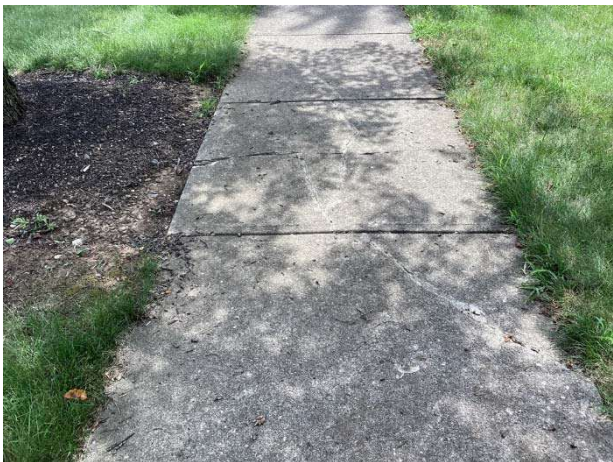
Sidewalk cracks near gazebo

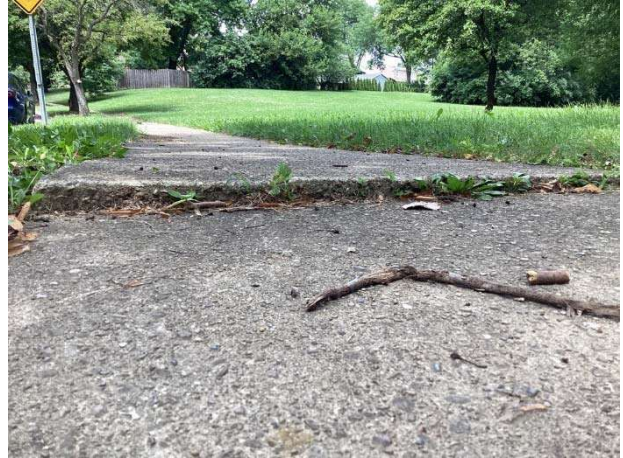
Condition: Fair overall with isolated cracks and deterioration evident. The Board informs us of isolated issues with tree roots causing upheaval.

Sidewalk upheaval at Little Jeep Park

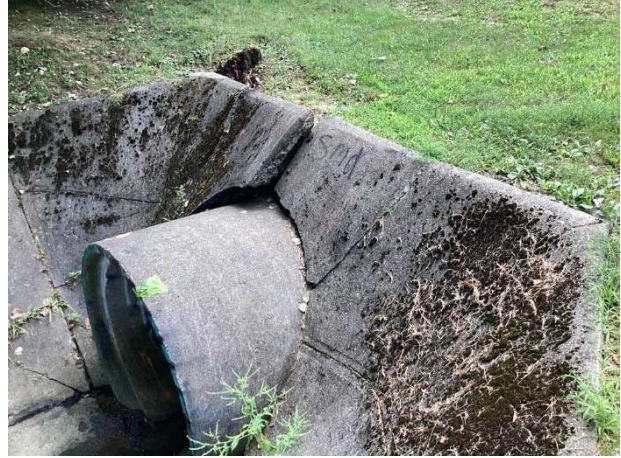
Culvert damage

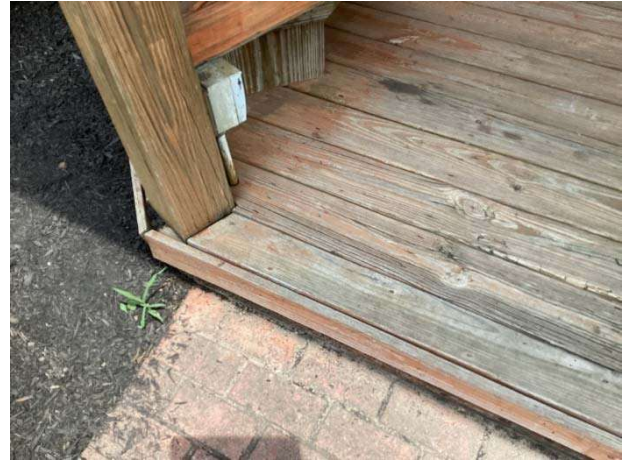
Condition: Fair overall with isolated finish deterioration evident.

Gazebo decking (note finish deterioration)

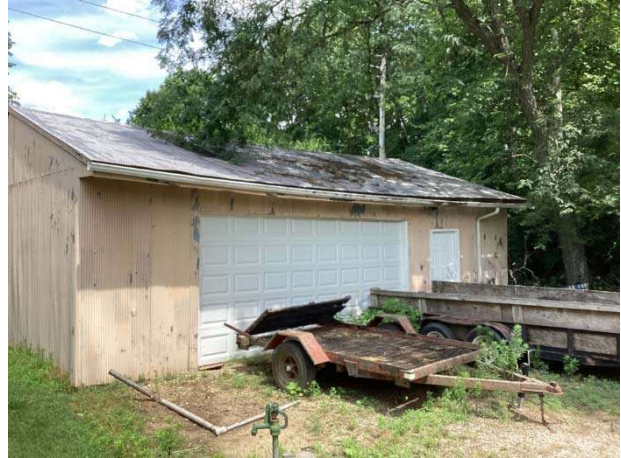
Roof damage and apparent structural damage

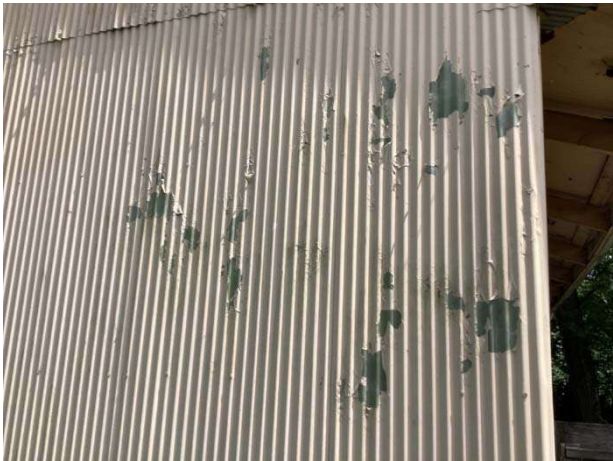
Siding damage

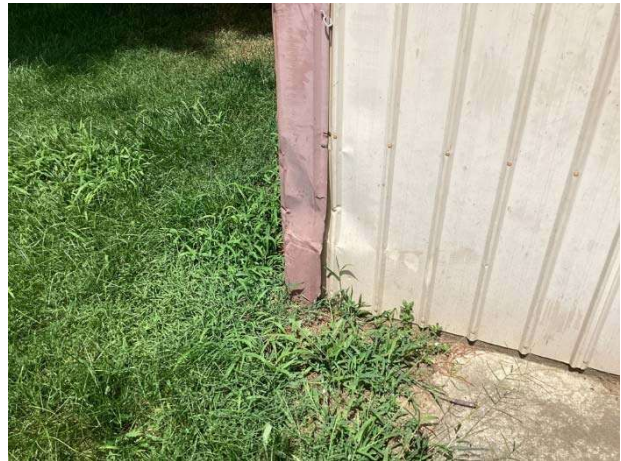
Siding damage

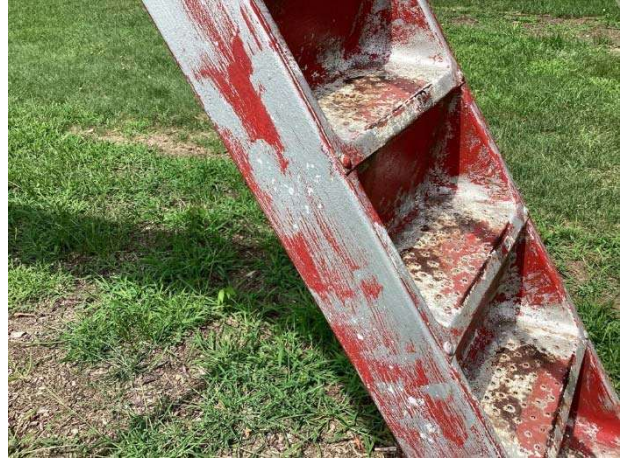
Forest Ridge Boulevard finish deterioration and rust

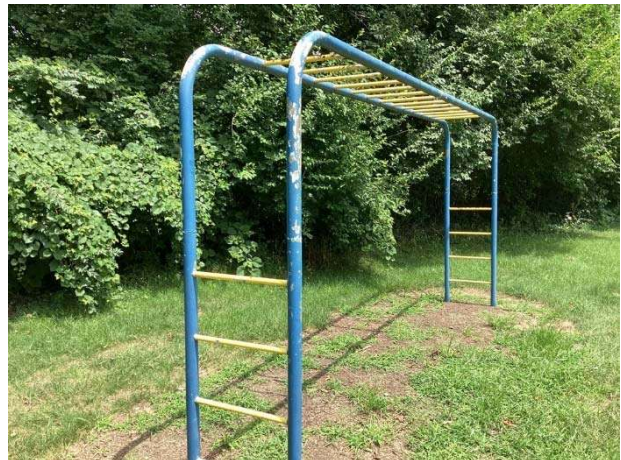
Forest Ridge Boulevard monkey bars (note finish deterioration)

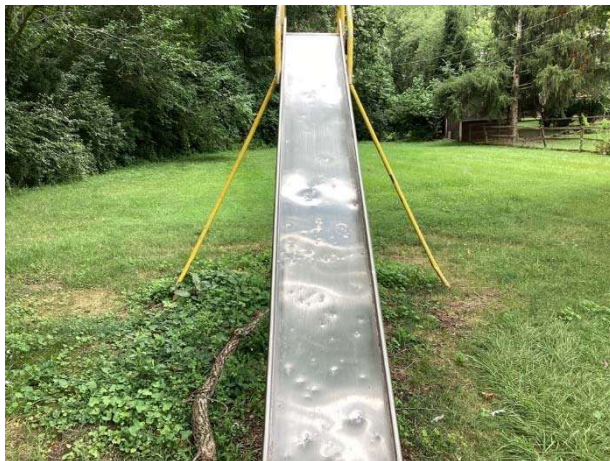
Meadowsweet Drive slide damage

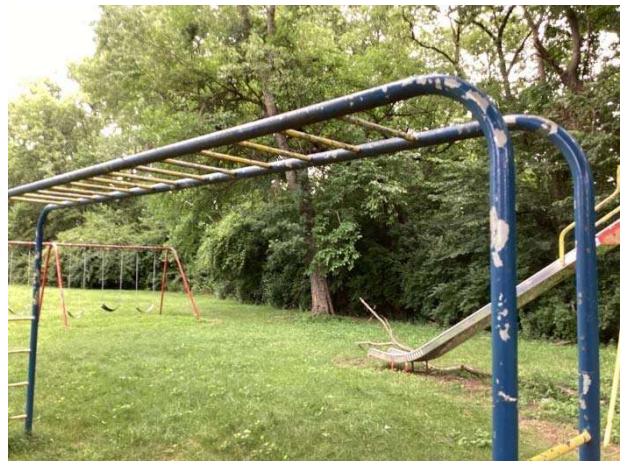
Meadowsweet Drive finish deterioration

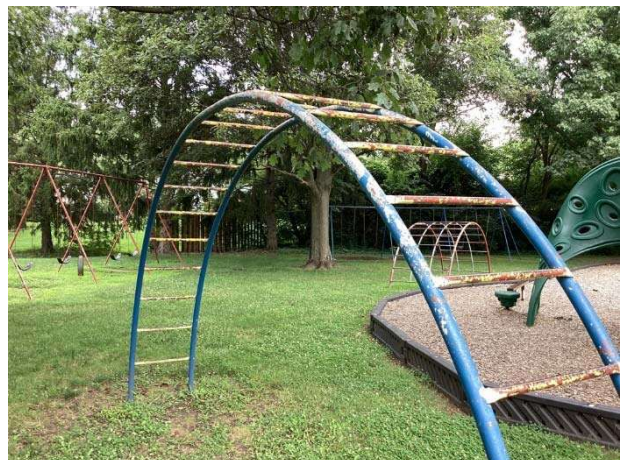
Pool house equipment finish deterioration

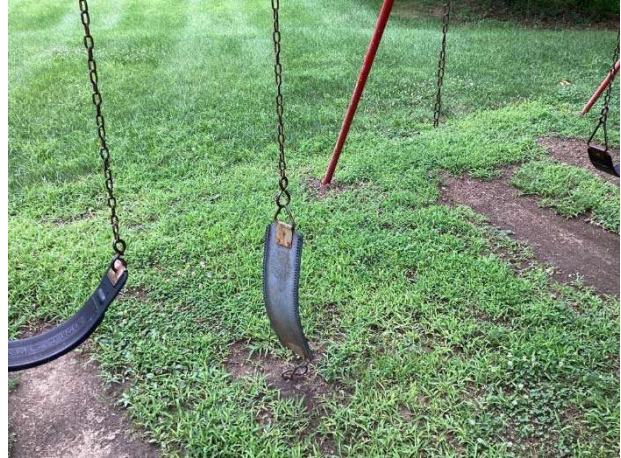
Damaged swing (pool house playground shown)

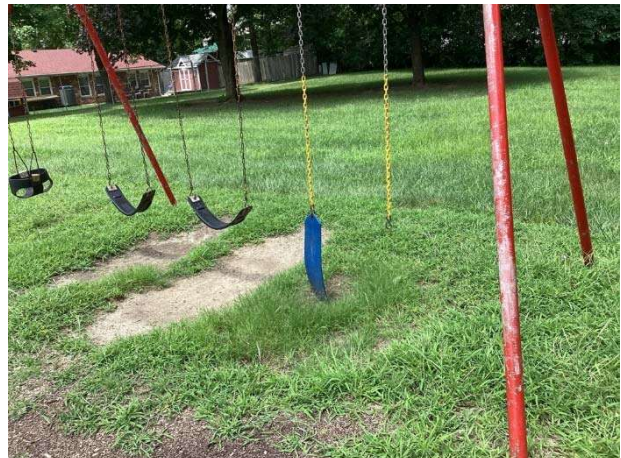
Willow Branch Drive damaged swing

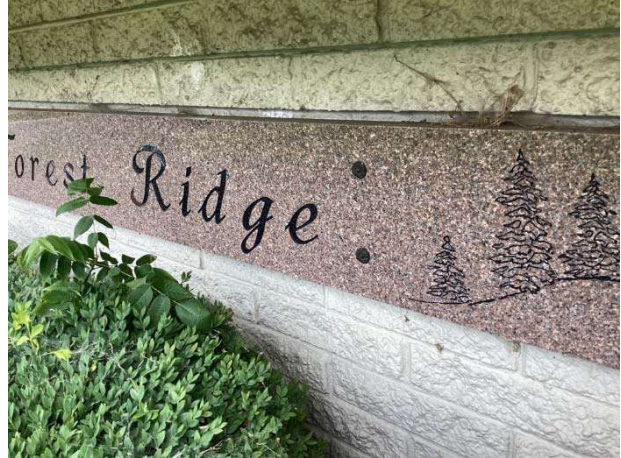
Sign deterioration

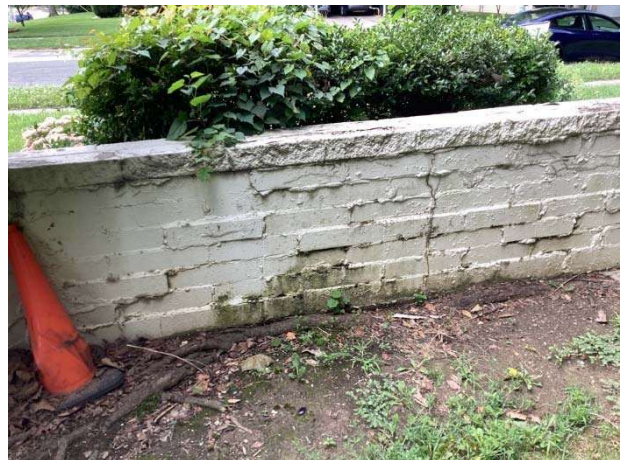
Cracks and damage

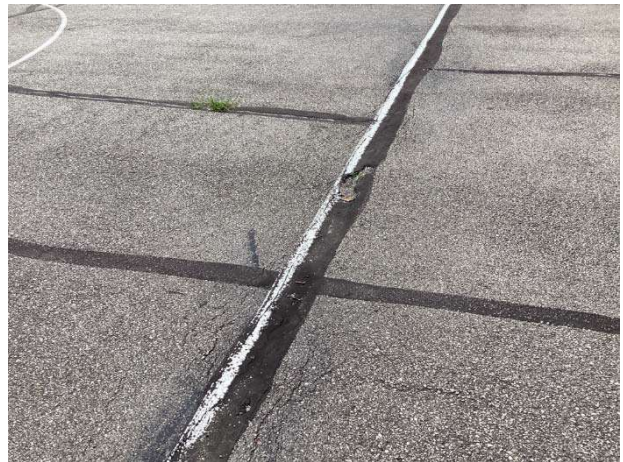
Condition: The pool house surfaces are in poor overall condition with systemic cracks, settlement, poor drainage, standards damage and color coat fade evident. The Willow Branch Drive surfaces are in fair overall condition with isolated cracks evident.

Pool house basketball court surface cracks and deterioration

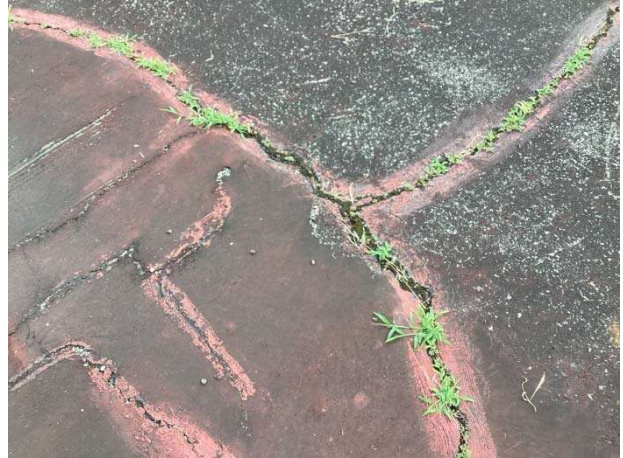
Pool house tennis court surface cracks

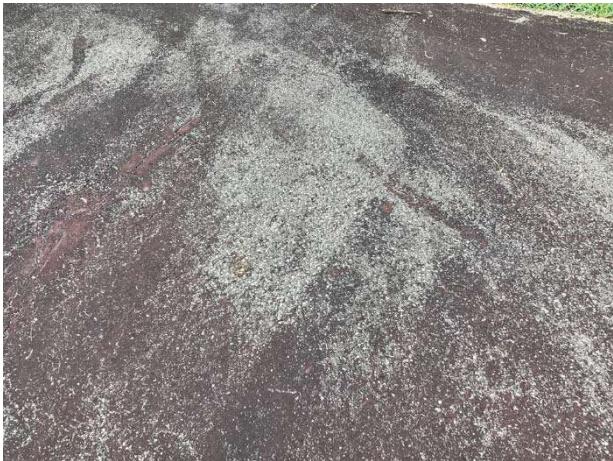
Pool house color coat fade

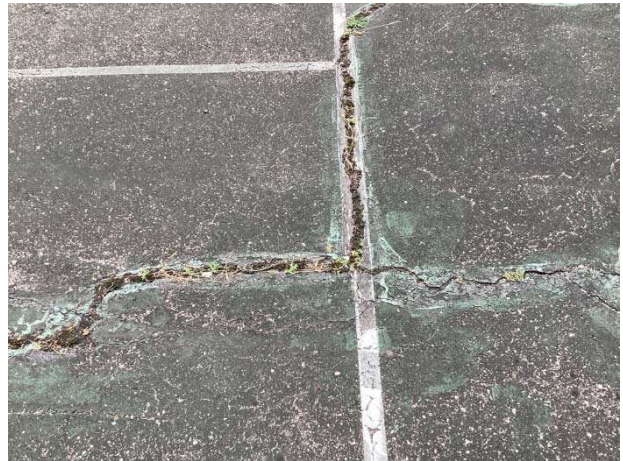
Pool house tennis court surface cracks

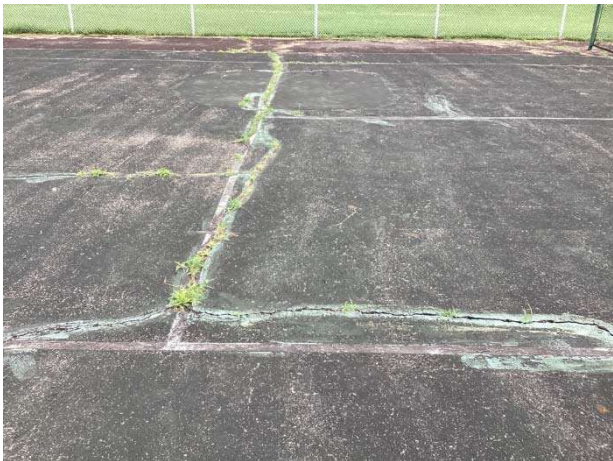
Pool house tennis court surface cracks

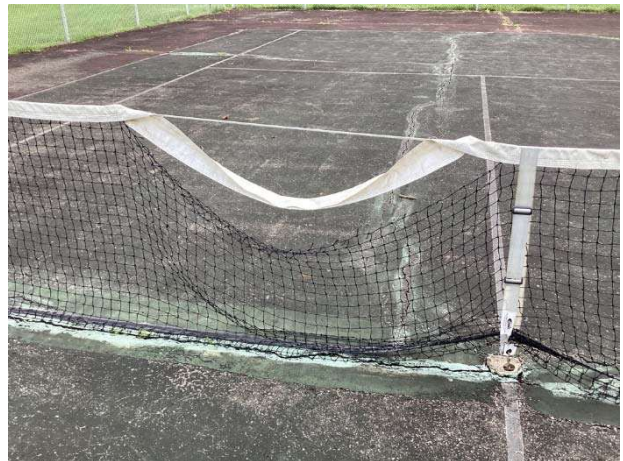
Pool house tennis court cracks (note net damage)

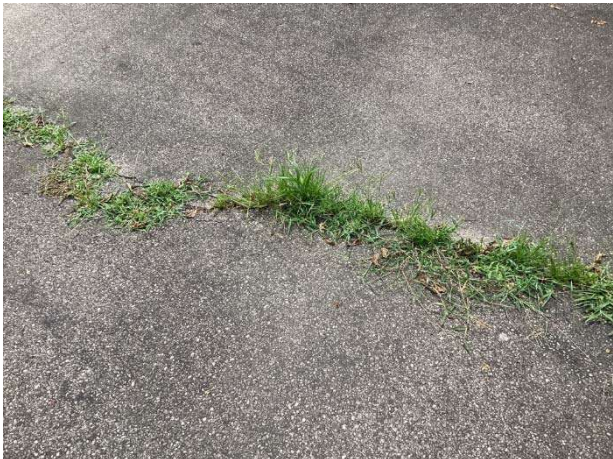
Willow Branch Drive surface cracks

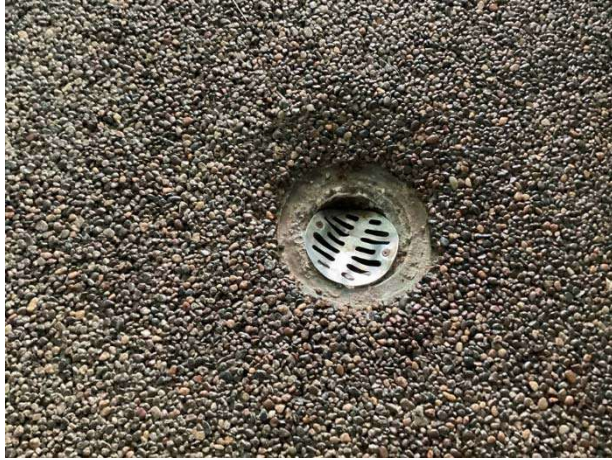
Displaced drain cover

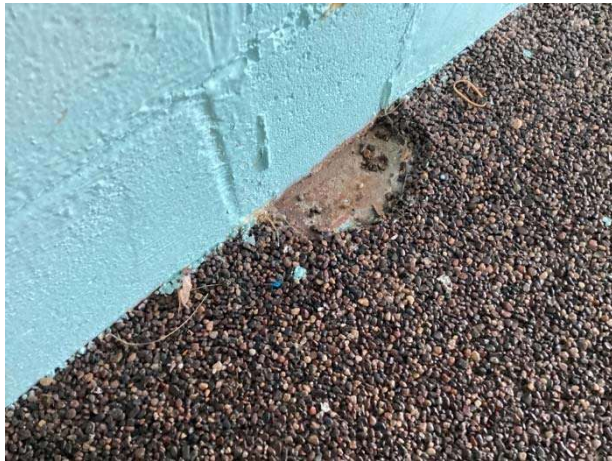
Missing floor coverings

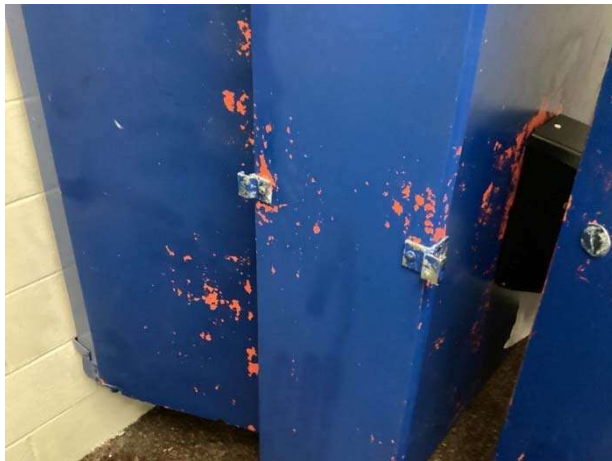
Partition finish deterioration

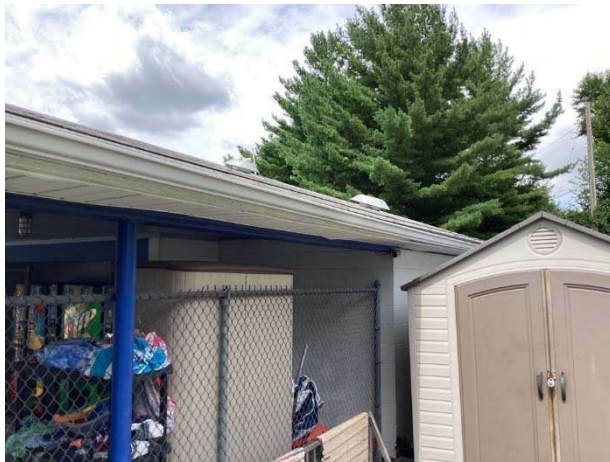
Condition: Fair to poor overall with isolated cupped shingles, gutter deflection, incorrect slope and sheathing deflection evident from our visual inspection from the ground. The Board does not report a history of leaks.

Gutter deflection

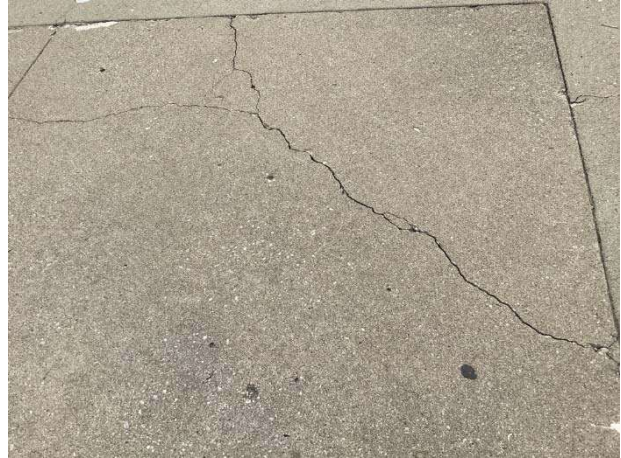
Concrete cracks

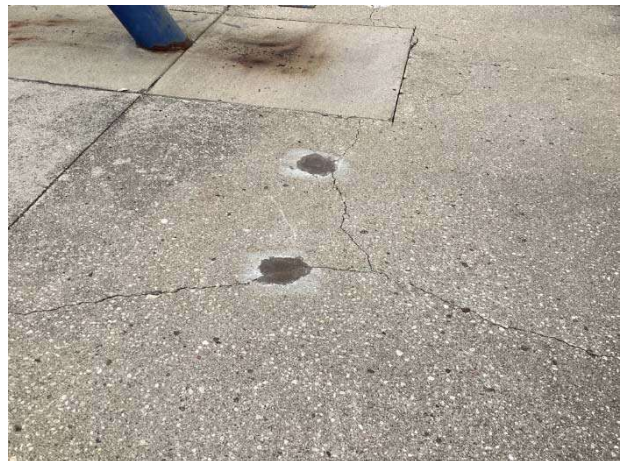
Concrete cracks

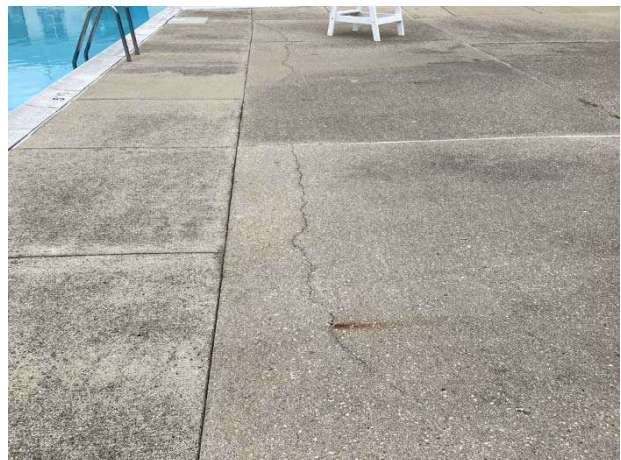
Concrete cracks

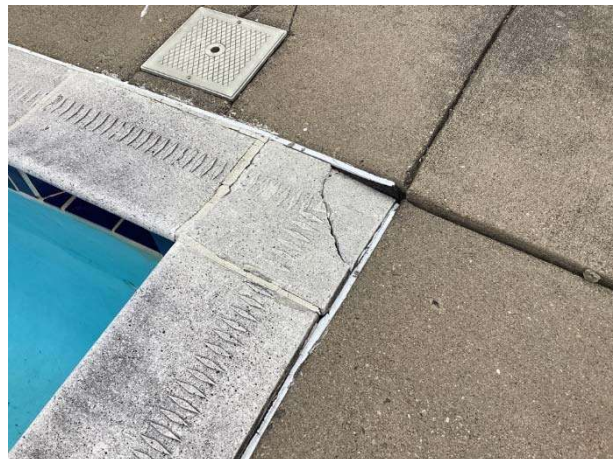
Coping damage

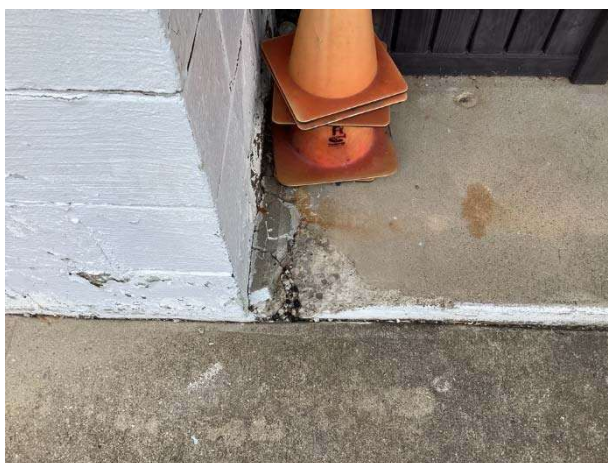
Concrete damage

Useful Life: The useful life of a concrete pool deck is up to 60 years or more with timely repairs. We recommend the Association conduct inspections, partial replacements and repairs to the decks every 8- to 12-years.

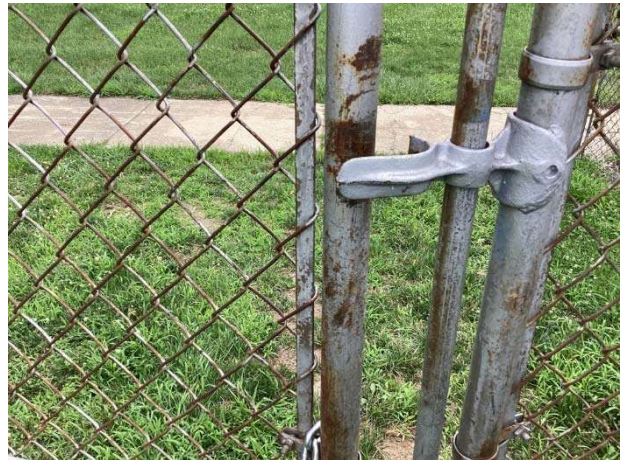
Fence post rust

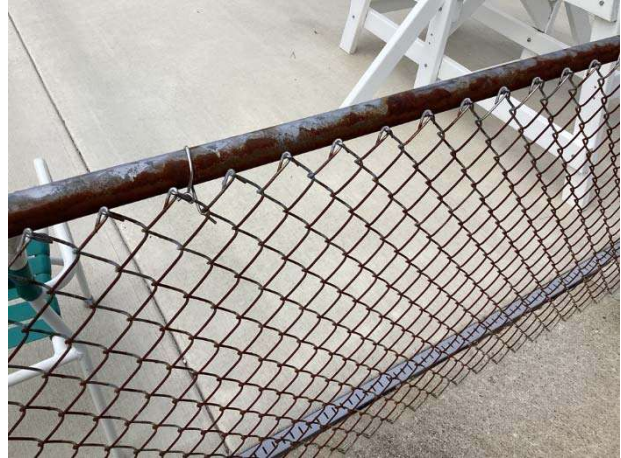
Fence post rust

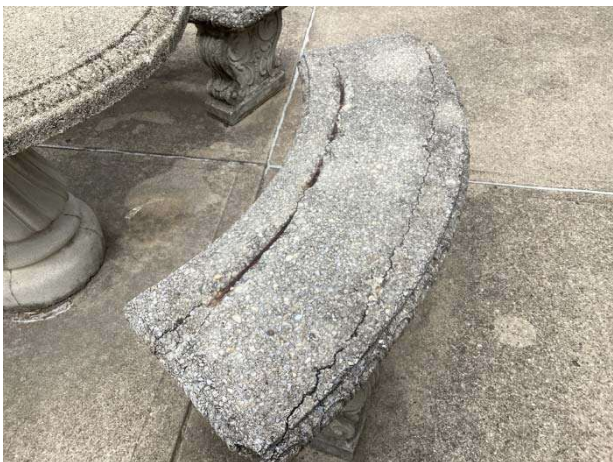
Concrete seat damage

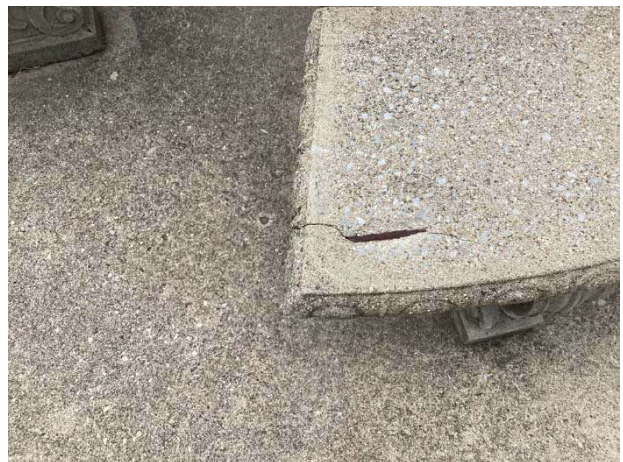
Concrete seat damage

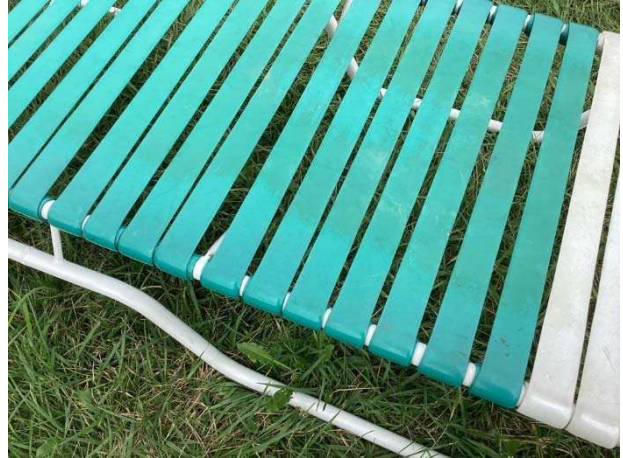
Worn vinyl

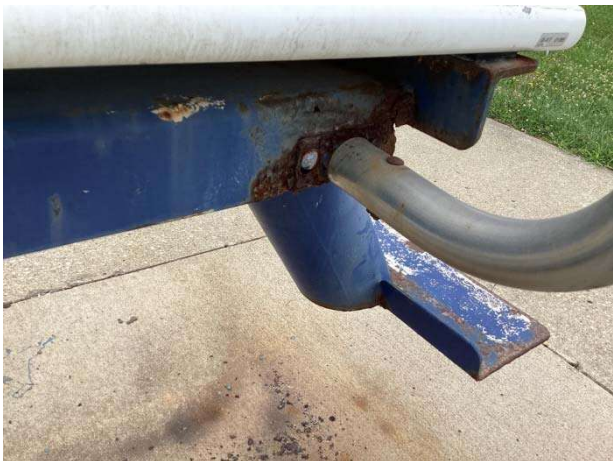
Diving board rust

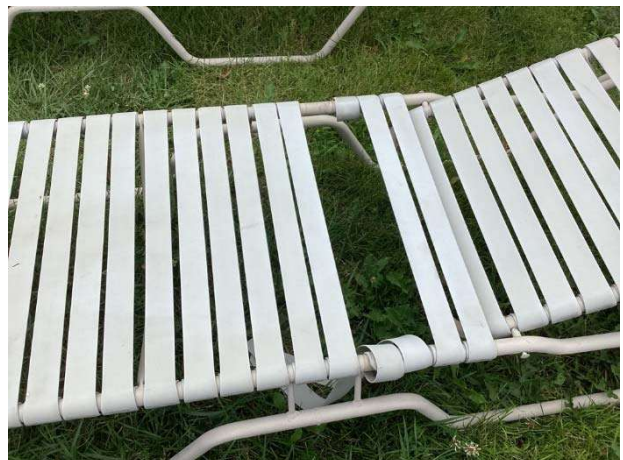
Furniture damage

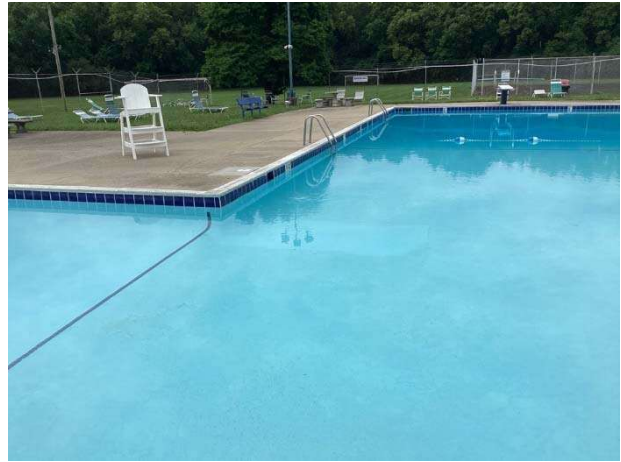
Condition: Fair to poor overall with isolated cracks and reported water loss.

Plaster floor repair
