The Forest Ridge Association

Dayton, OH • July 29, 2022

FULL RESERVE STUDY

Visual Inspection and Report by: Matthew C. Ferguson, RS¹

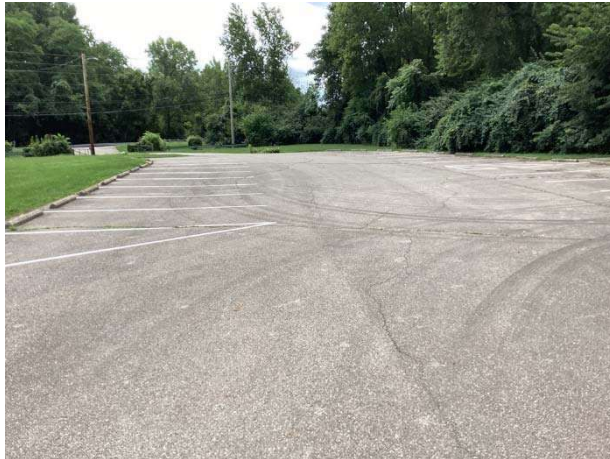
Condition: Fair overall with isolated cracks and deterioration evident

Pool house parking area

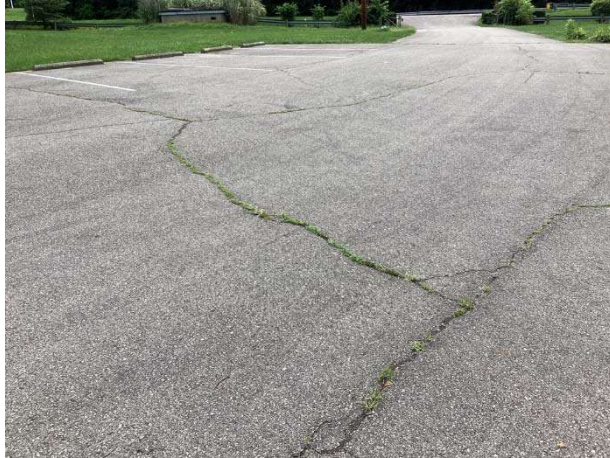
Willow Branch Drive pavement cracks

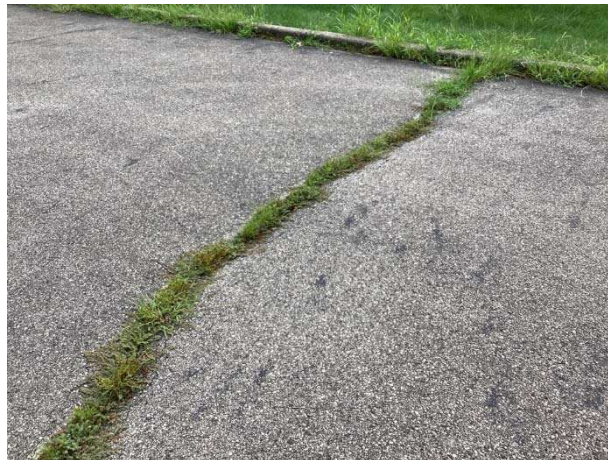
Willow Branch Drive pavement cracks (note organic growth)

Component Detail Notes: Patch repairs are conducted at areas exhibiting settlement, potholes, or excessive cracking. These conditions typically occur near high traffic areas, catch basins, and pavement edges.

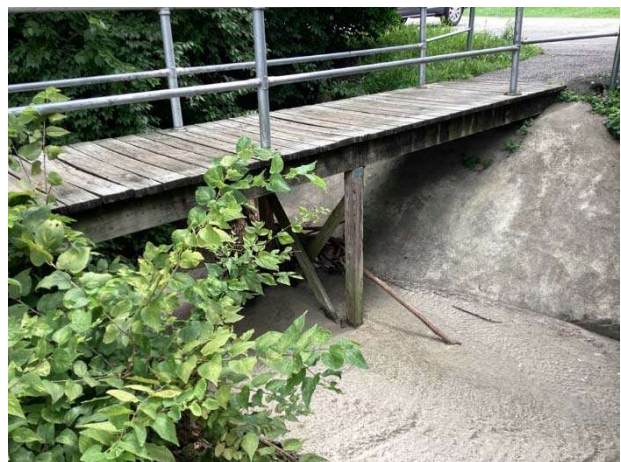
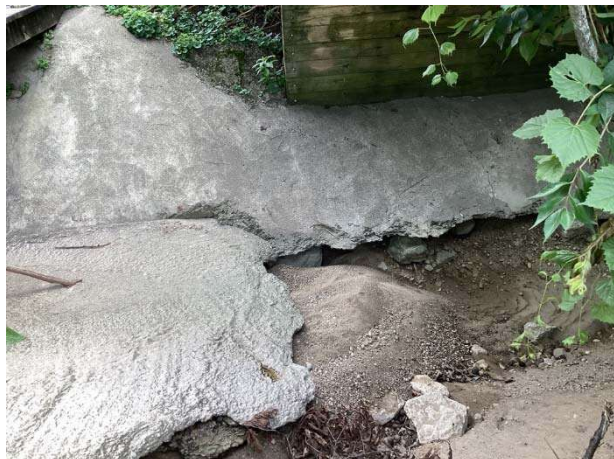
History: Varied ages. The Association has conducted erosion remediation along the shoreline in the past. The Board informs us the remediation is satisfactory and do not foresee a need for future remediation.

Erosion remediation

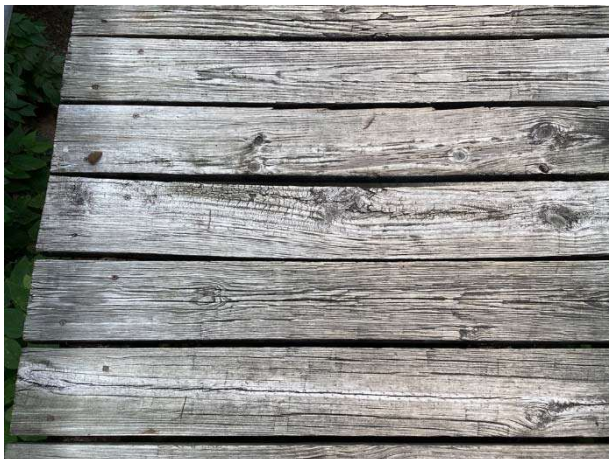
Condition: Fair overall with isolated deterioration, wood split and erosion remediation evident.

Weathered deck boards

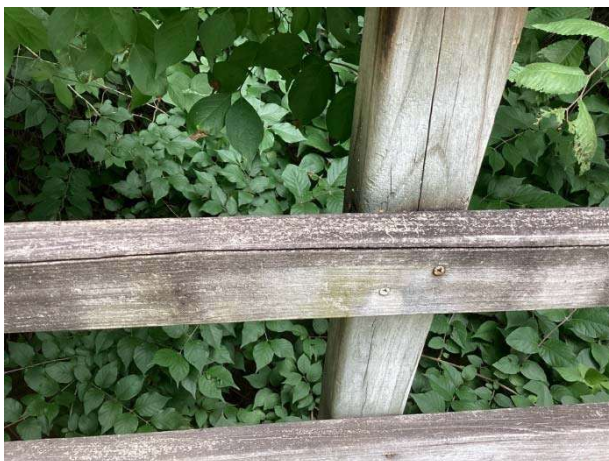
Railing wood split

Useful Life: 15- to 25-years. The rates and types of deterioration are not uniform due to the nature of wood. Replacement is normally an ongoing process which eventually leads to a complete replacement for economic or aesthetic reasons.

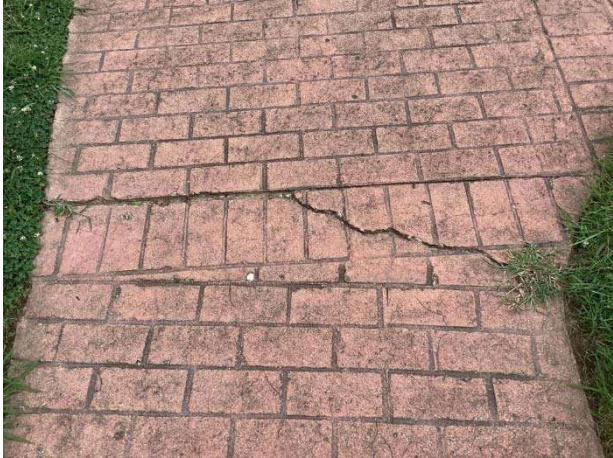
Stamped sidewalk cracks

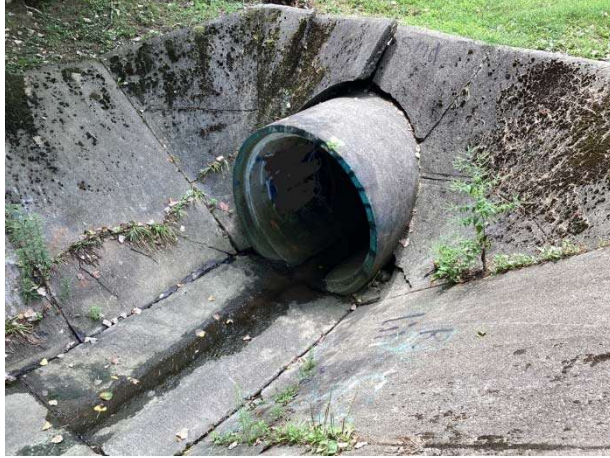
Condition: Poor overall with periodic cracks, settlement and damage evident.

Culvert overview

Useful Life: Inspections and repairs every 10- to 15-years. Repairs may include crack repairs and partial replacement of concrete. However, the exact scope of work may vary and we recommend the Association consult with an engineer to conduct an invasive inspection.

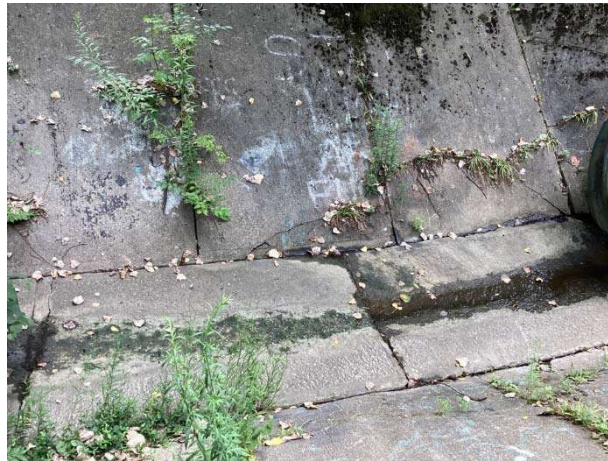
Culvert cracks

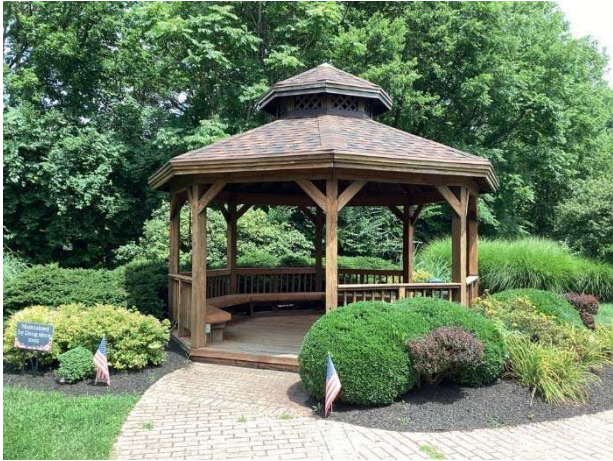
Condition: Fair overall with isolated finish deterioration evident.

Gazebo

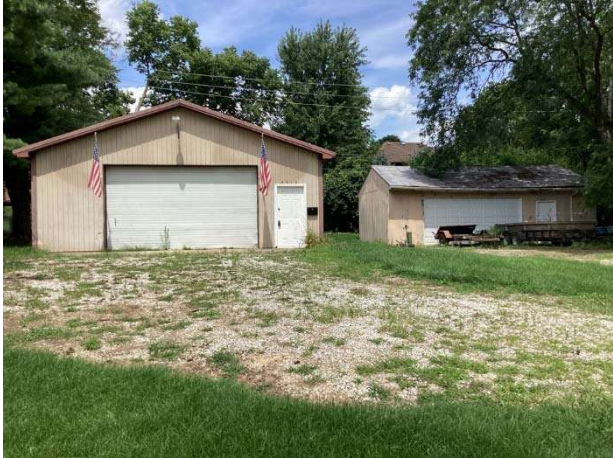
Condition: Poor overall. We note systemic damage, deterioration and likely roof structure damage at the east building.

Maintenance sheds

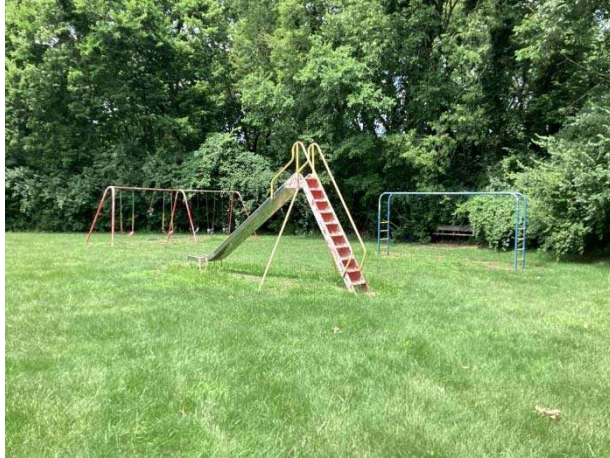
Condition: The newly installed equipment is in good overall condition and the remaining equipment is in fair to poor overall condition with periodic finish deterioration, rust and damage evident.

Forest Ridge Boulevard playground equipment

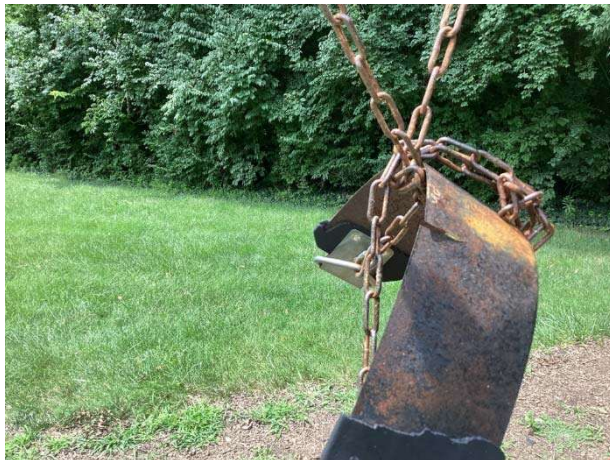
Forest Ridge Boulevard swing damage

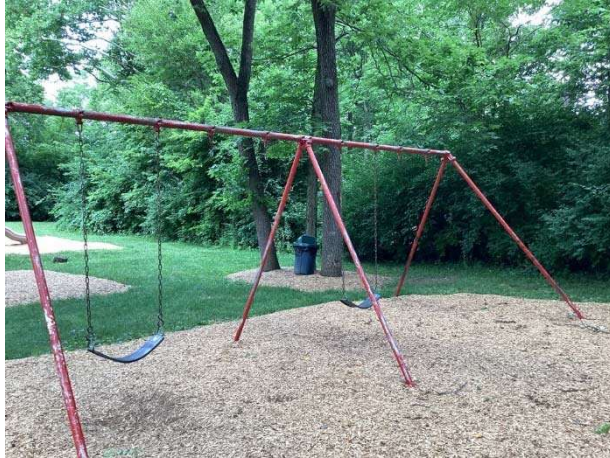
Little Jeep playground missing swings

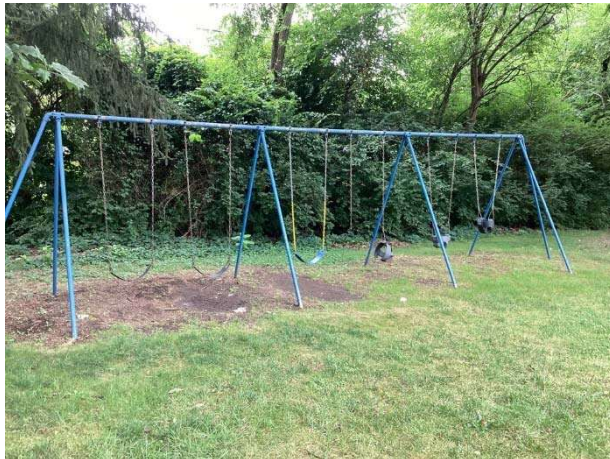
Pool house alternate swings (note damage)

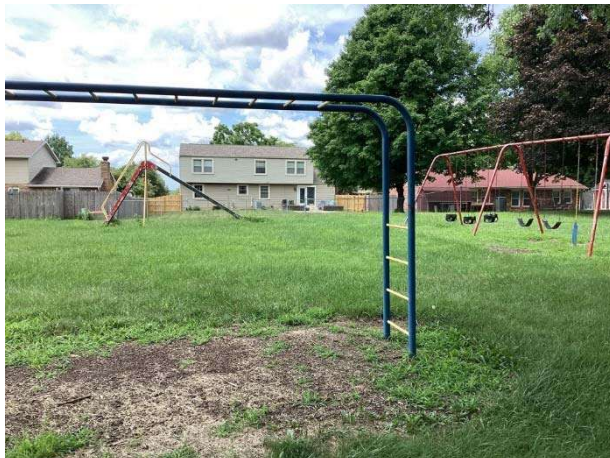
Willow Branch Drive playground equipment

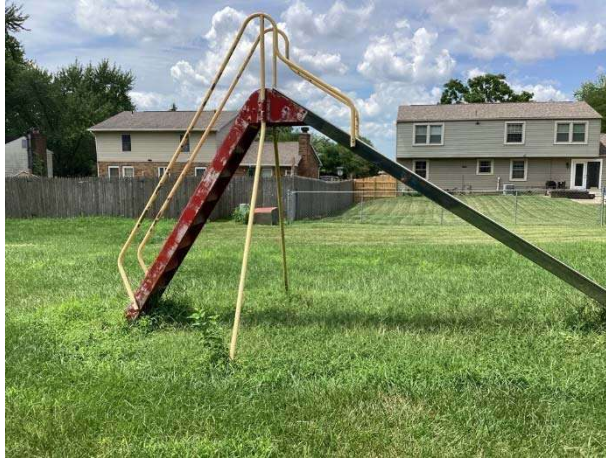
Willow Branch Drive playground equipment

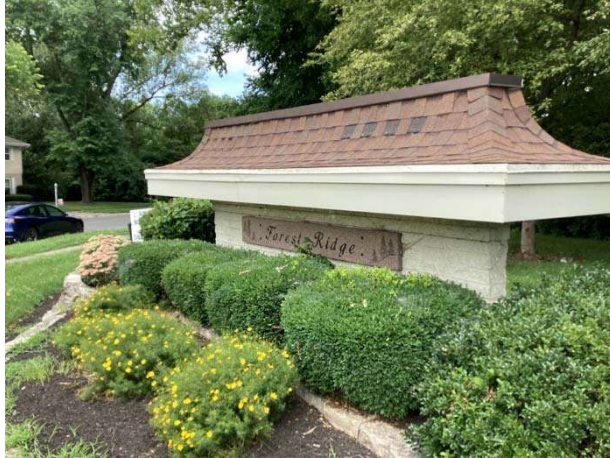
Condition: Poor overall with periodic deterioration and damage evident.

Entrance monument

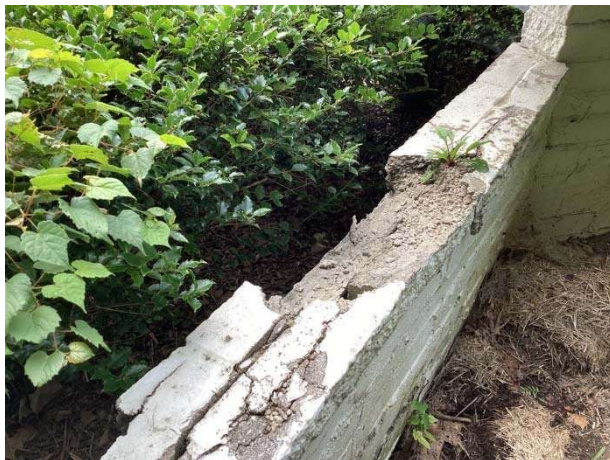
Masonry damage

Expenditure Detail Notes: Expenditure timing and costs are depicted in the **Reserve Expenditures** table in Section 3. Our cost for renovation includes repairs to the masonry and replacement of the remaining components listed above.

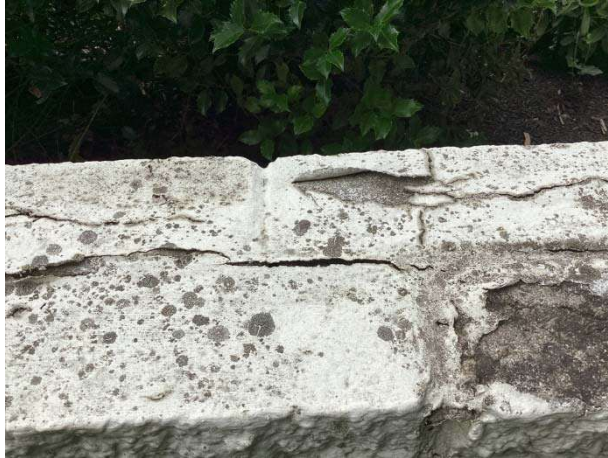
Paint finish deterioration

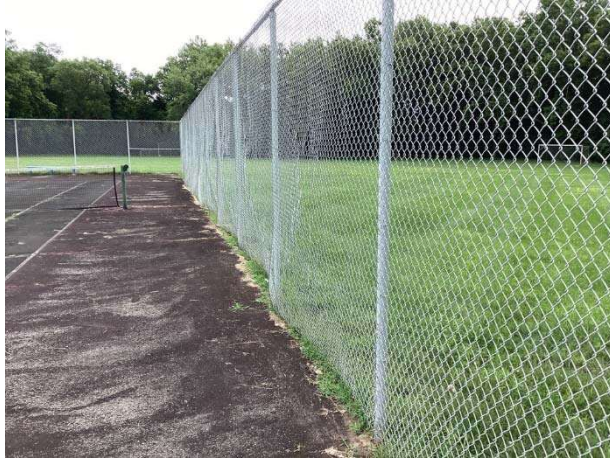
Condition: The pool house fence is in fair overall condition with isolated warped webbing evident. The Willow Branch Drive fence is in fair to poor condition with periodic rust and warped webbing evident.

Chain link fence (note warped webbing)

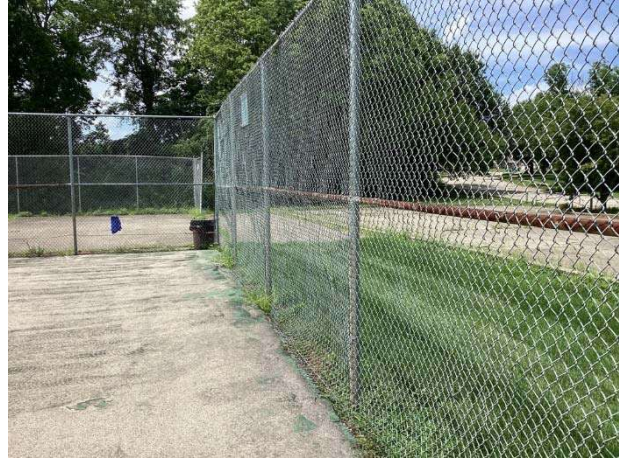
Willow Branch Drive fence (note warped webbing)

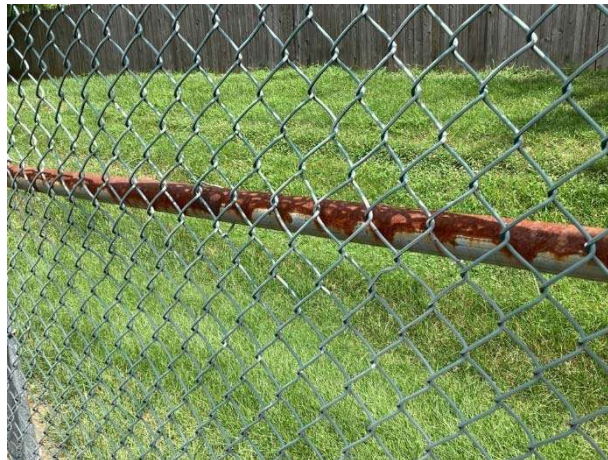
Willow Branch Drive fence post rust

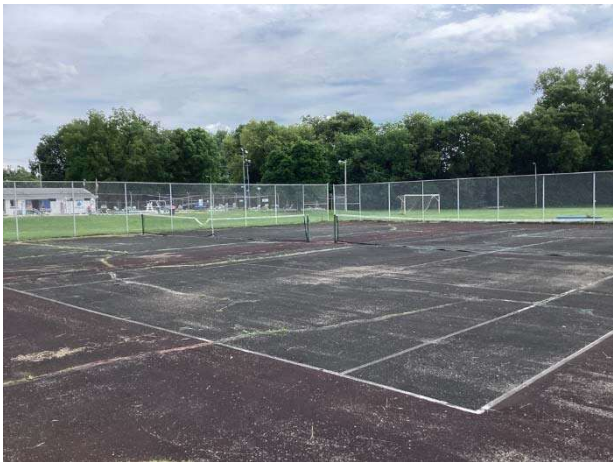
Condition: The pool house surfaces are in poor overall condition with systemic cracks, settlement, poor drainage, standards damage and color coat fade evident. The Willow Branch Drive surfaces are in fair overall condition with isolated cracks evident.

Pool house tennis court overview

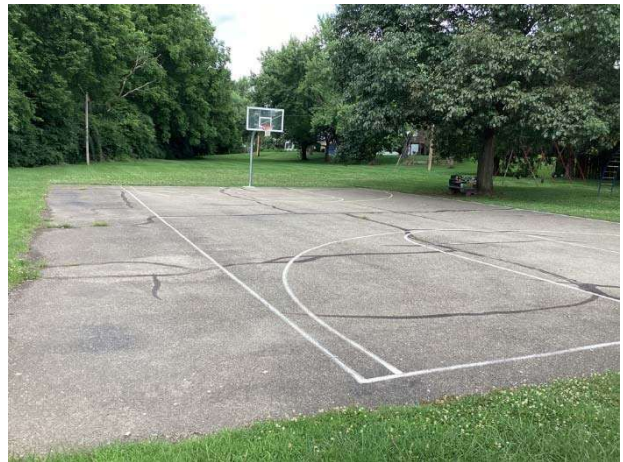
Pool house basketball court overview

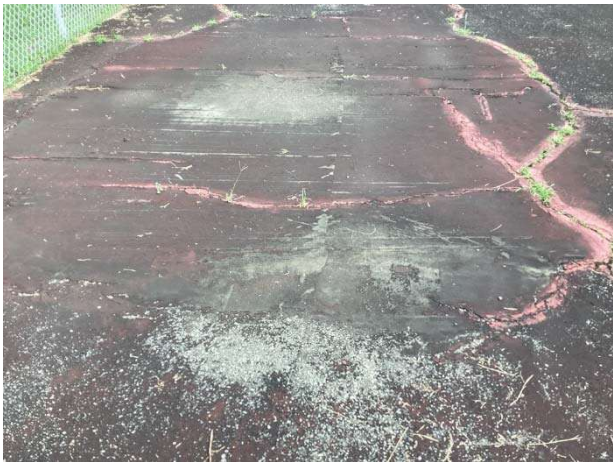
Pool house court repair

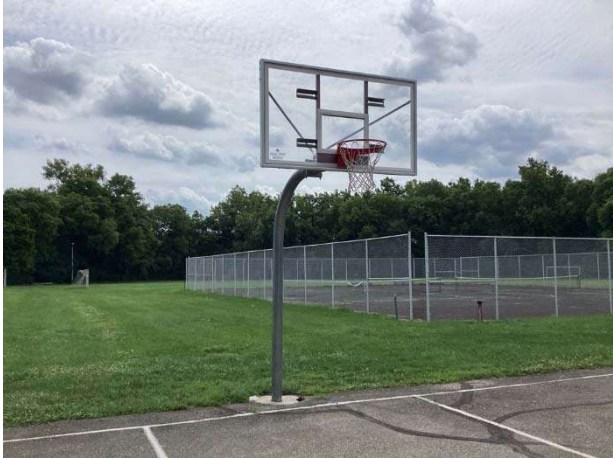
Basketball goal

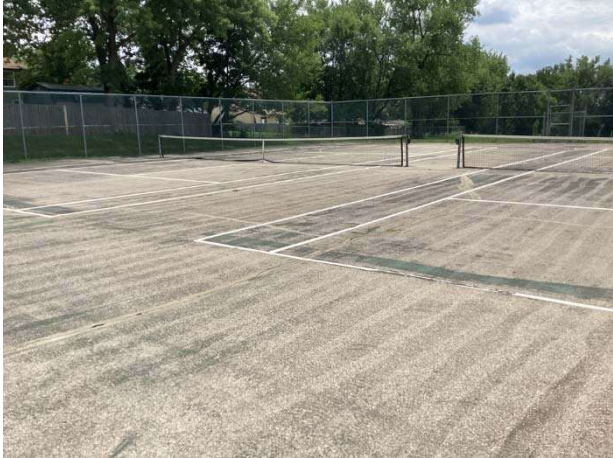
Willow Branch Drive tennis court overview

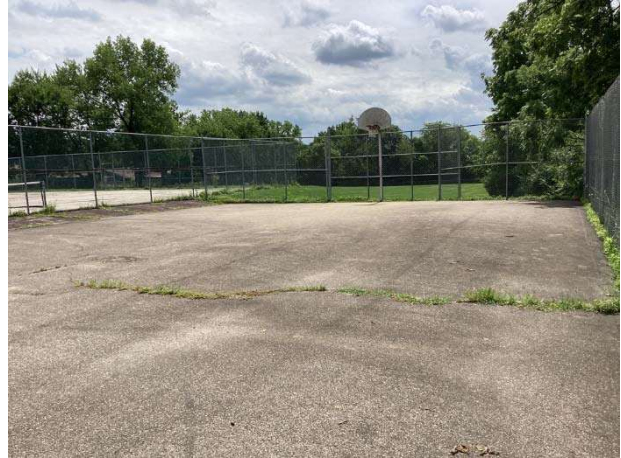
Willow Branch Drive basketball court overview

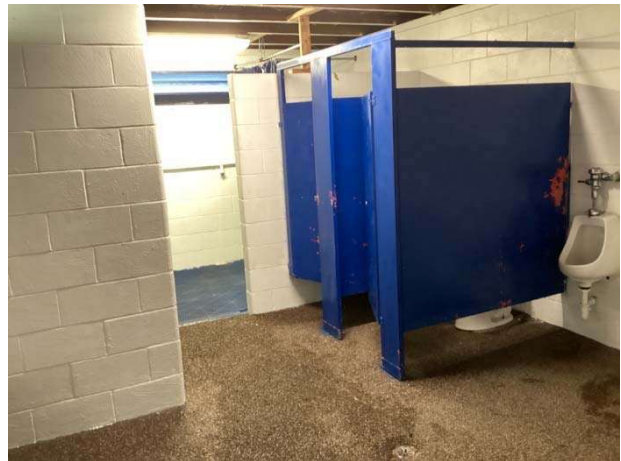
Rest room overview

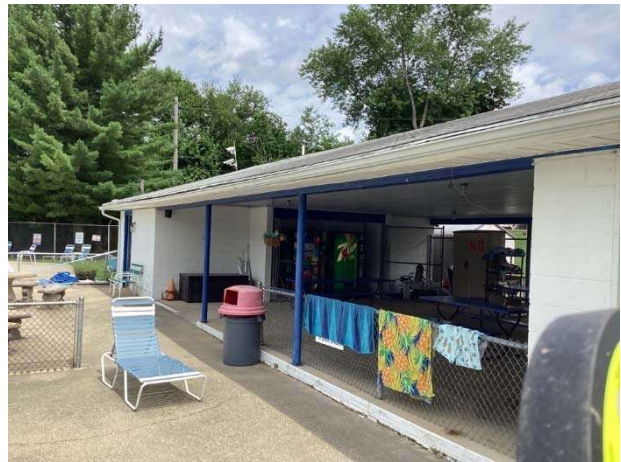
Incorrect slope

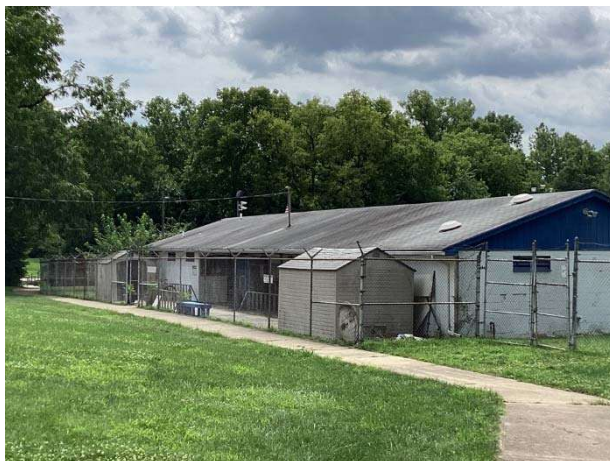
Discoloration

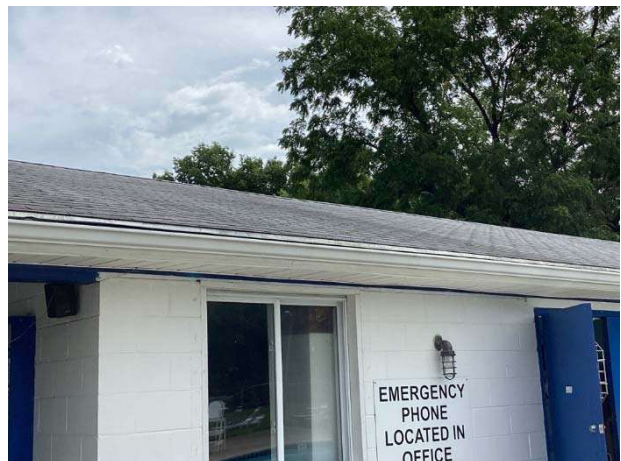
Condition: Fair to poor overall with isolated cupped shingles, gutter deflection, incorrect slope and sheathing deflection evident from our visual inspection from the ground. The Board does not report a history of leaks.

Roof overview

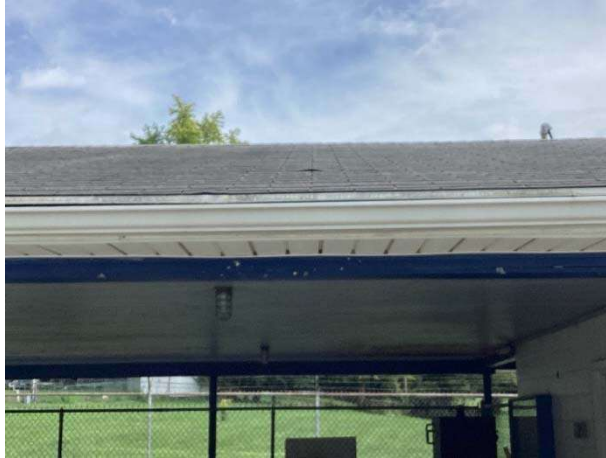
Shingle curl

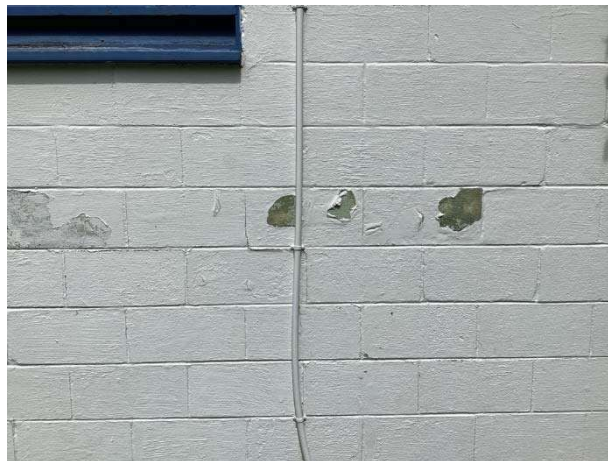
- Minimal previous repairs evident
- Masonry exhibits isolated cracks
- Masonry exhibits minor spalls

Paint finish deterioration

- Complete inspection of the masonry and paint finish applications
- Repointing of up to ten percent (10%) of the masonry
- Replacement of a limited amount of the masonry (The exact amount of area in need of replacement will be discretionary based on the actual future conditions and the desired appearance.)
- Paint finishes and capital repairs to the soffit and fascia
- Paint finishes to the masonry

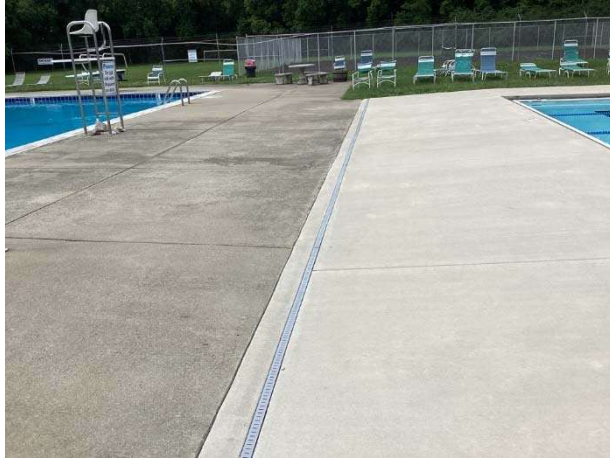
Recently replaced deck

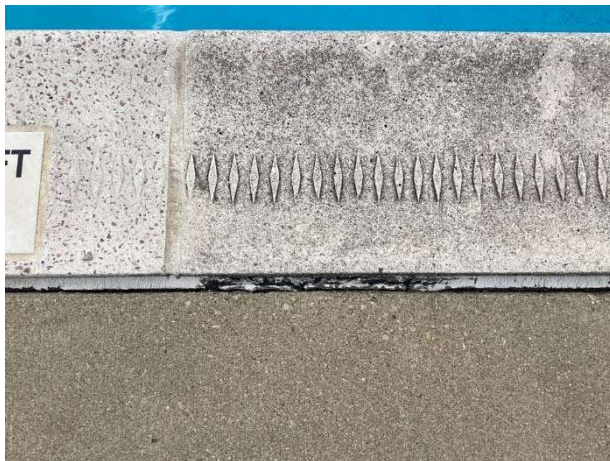
Joint sealant deterioration

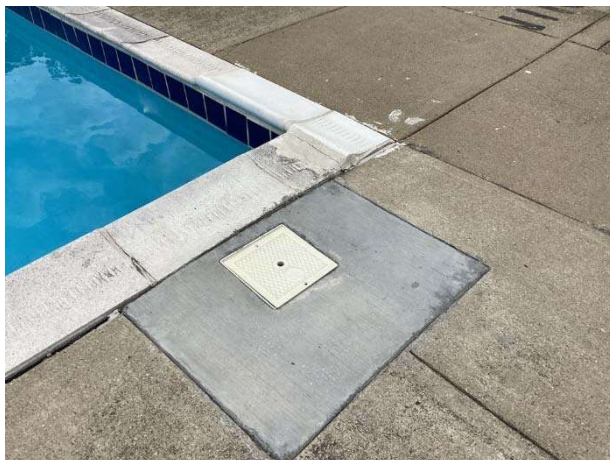
Concrete repair (note coping repair)

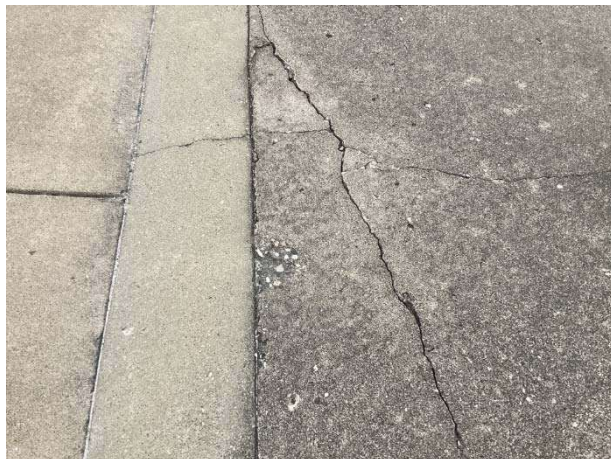
Concrete cracks and damage

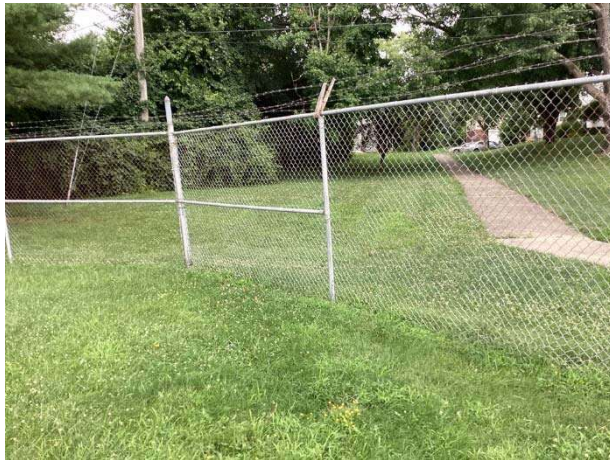
Condition: Fair overall with periodic rust evident.

Chain link pool fence

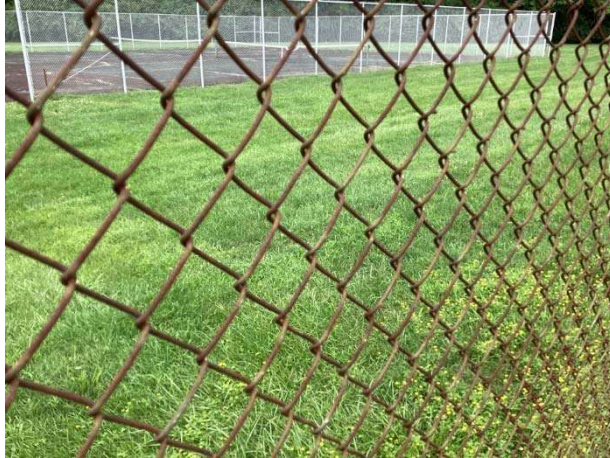
Webbing rust

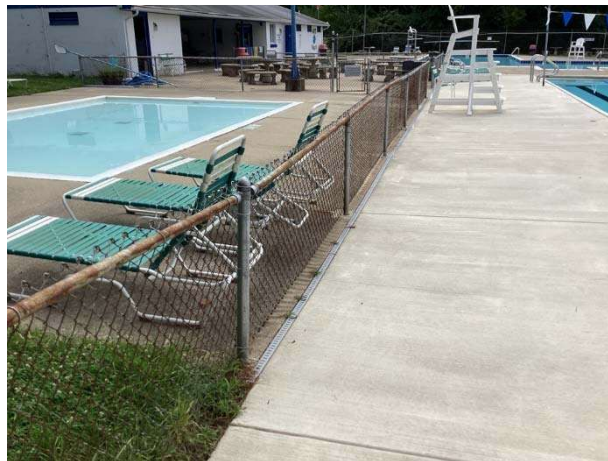
Baby pool fence

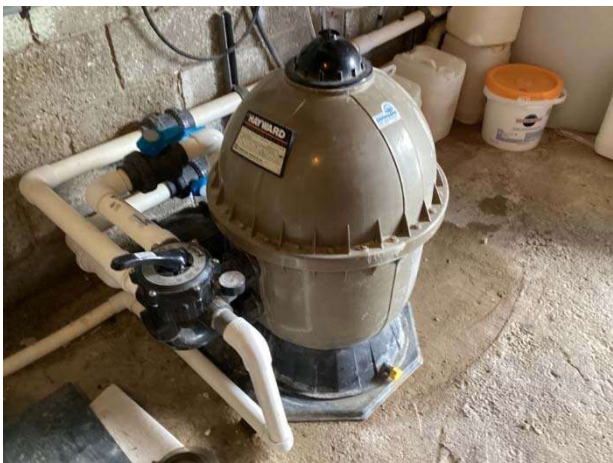
Pool filter

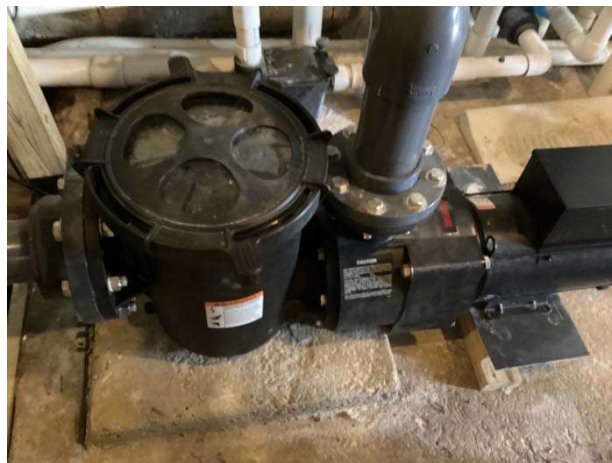
Condition: Reported satisfactory without operational deficiencies.

Pool pump

Expenditure Detail Notes: Expenditure timing and costs are depicted in the **Reserve Expenditures** table in Section 3. Failure of the pool mechanical equipment as a single event is unlikely. Therefore, we include replacement of up to twenty-five percent (25%) of the equipment per event. We consider interim replacement of motors and minor repairs as normal maintenance.

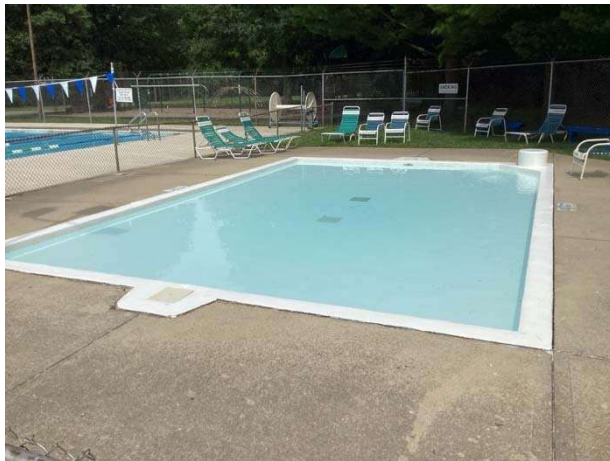
Condition: Good overall

Baby pool

- Removal and replacement of the paint finishes
- Partial replacements of the scuppers and coping as needed
- Replacement of joint sealants as needed
- Concrete structure repairs as needed

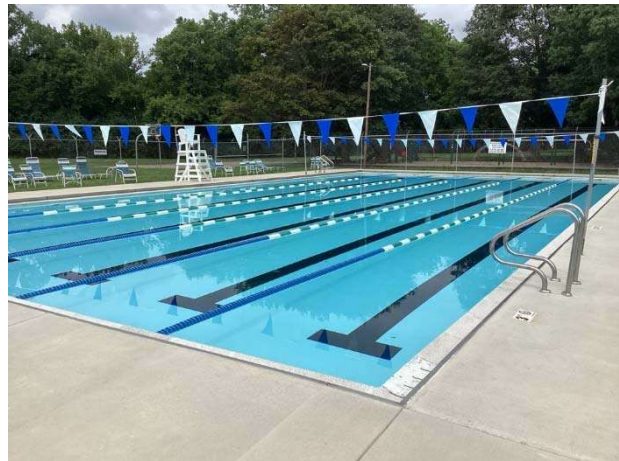
Competition pool

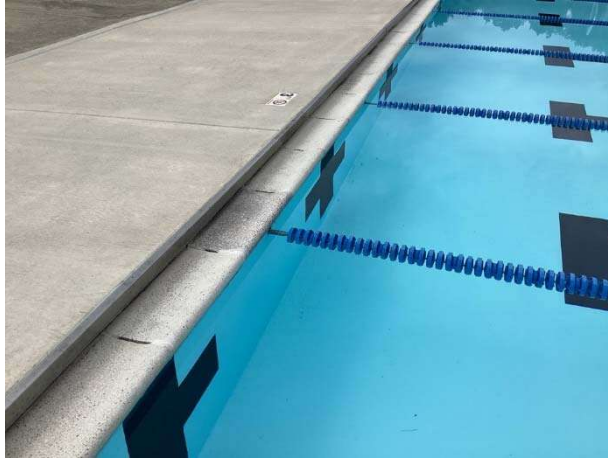
Competition pool detail

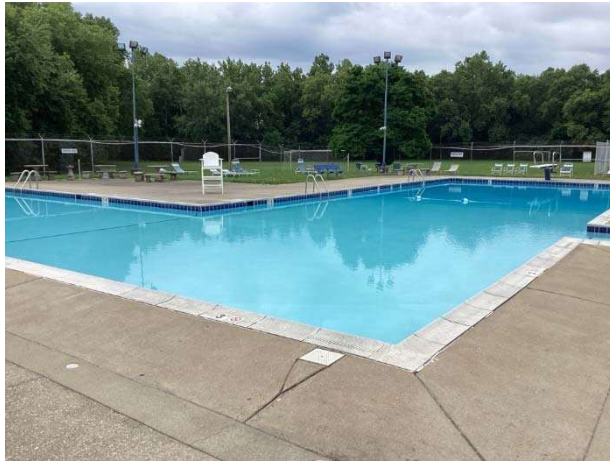
Condition: Fair to poor overall with isolated cracks and reported water loss.

“L” shaped pool overview

- Removal and replacement of the plaster finishes
- Partial replacements of the scuppers and coping as needed
- Replacement of tiles as needed
- Replacement of joint sealants as needed
- Concrete structure repairs as needed

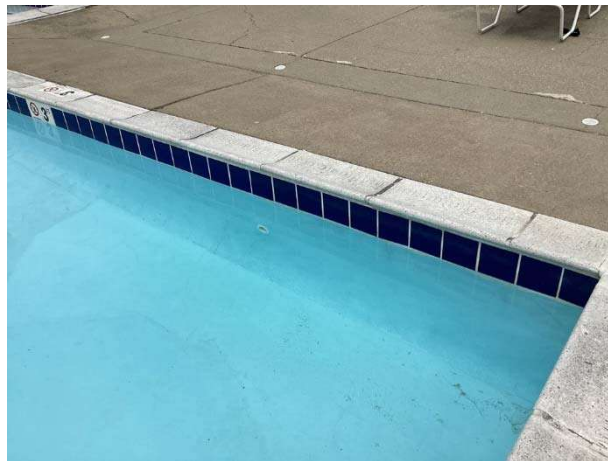
Pool plaster finish with tile perimeter
